AD-A231 443 SSC-337

SHIP FRACTURE MECHANISMS

**A NON-EXPERT'S GUIDE FOR
INSPECTING AND DETERMINING THE CAUSES OF
SIGNIFICANT SHIP FRACTURES**

SHIP STRUCTURE COMMITTEE

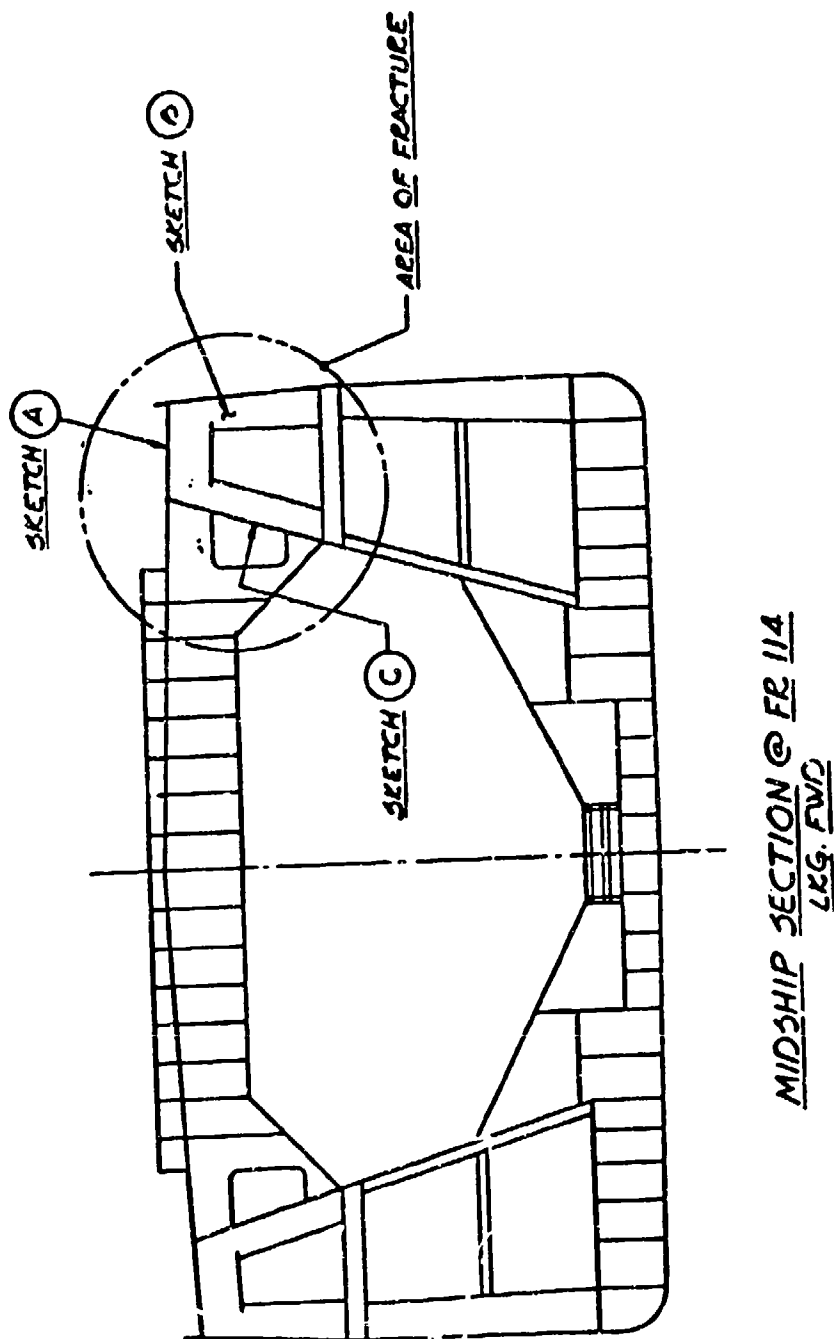
The fracture occurred on the bulk carrier on its last voyage prior to layup for the 1984 winter season. The ship was sailing Lake Huron when the crew heard a loud noise. An inspection by the crew revealed a fracture in the main deck on the starboard side near amidships.

Figure 4-1. Midship Section Indicating the Area of Fracture on the Great Lakes Bulk Carrier

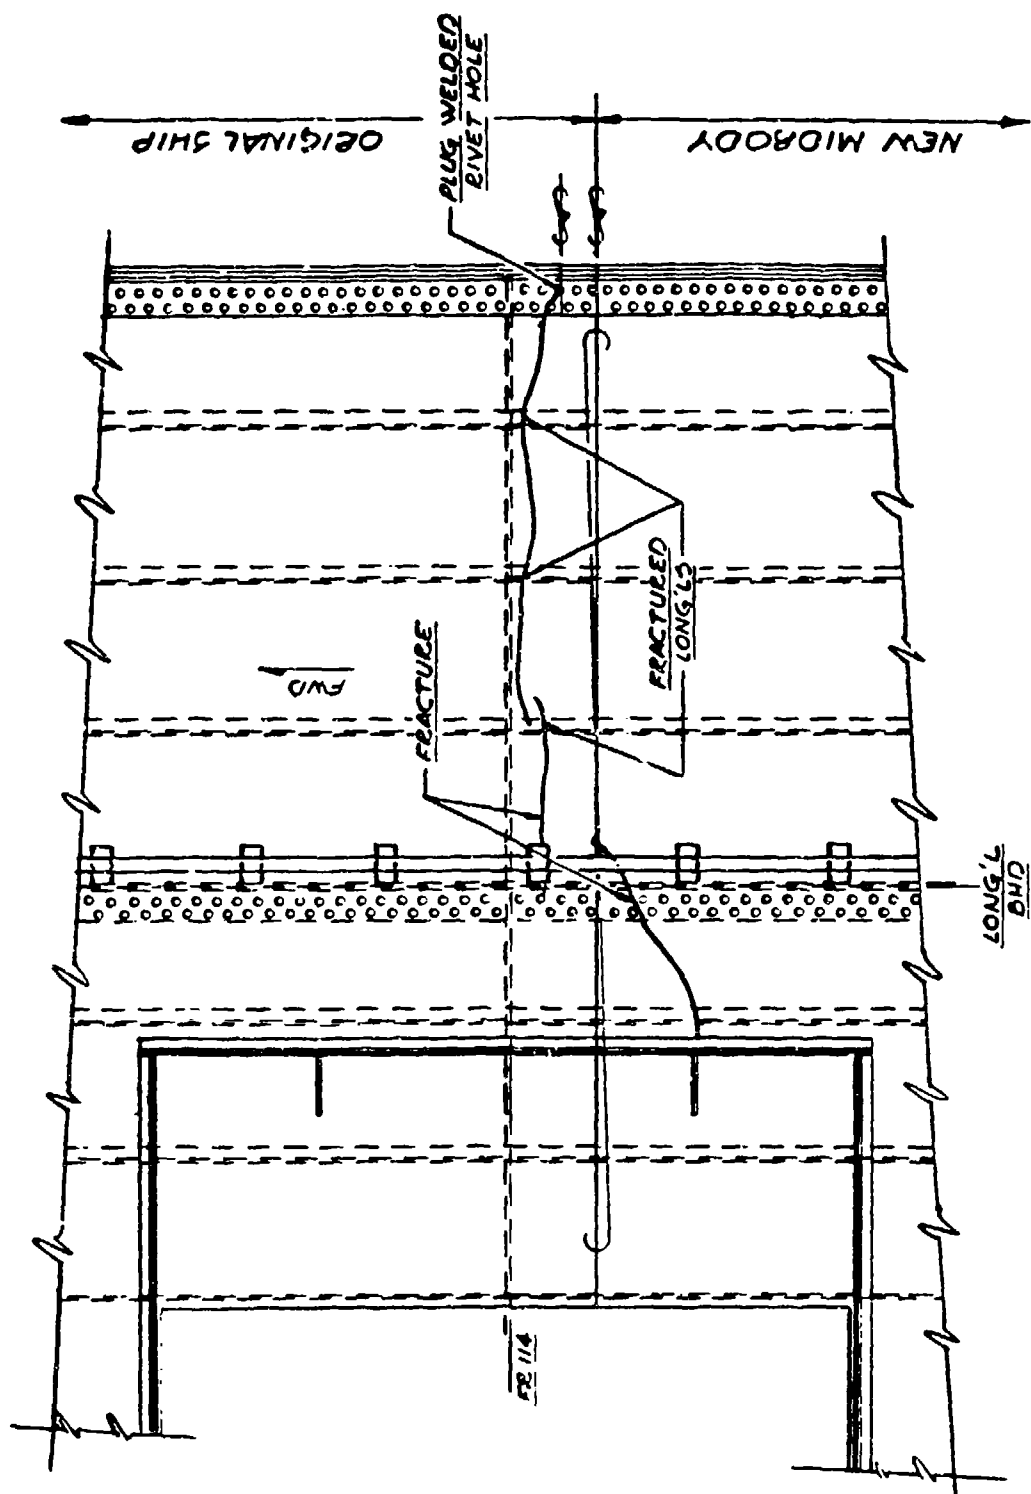
SKETCH A
PLAN OF SPAR DECK @ FR 114

Figure 4-3. Fracture Path on the Spar Deck of the Great Lakes Bulk Carrier

The fracture was examined on site. There were three separate fractures crossing the starboard side of the spar deck where the ship had been joined during the lengthening process. Two of the fractures occurred in the original ship and one in the new midbody section (Figure 4-3). Upon examination below the spar (main) deck the reason for the separate fractures became apparent. A number of poor fabrication details were used in lengthening the vessel. These included plug welded rivet holes, mismatched structural members, weld used as filler for mismatched areas and notched longitudinals. The longitudinals under the spar deck consisted of channels with the flange welded to the underside of the deck at the toe and heel. The flange was welded to the underside of the deck and was cut out in way of butt welds on the longitudinals as shown in Figure 4-5. The three outboard longitudinals all fractured at this location. The fracture path in the spar deck plate ran through the notches created at the longitudinal butt welds and ran into the longitudinal bulkhead (Figure 4-4). The fracture surface visible in the longitudinal bulkhead during the on-site examination exhibited the classic chevron markings indicative of a brittle fracture. However, the exact location of the fracture origin could not be determined on site because the edge of the entire fracture could not be inspected visually. Samples were cut out of the fractured plating for further examination of the fracture path. The locations of these samples in the spar deck and longitudinal bulkhead are shown in Figure 4-6.

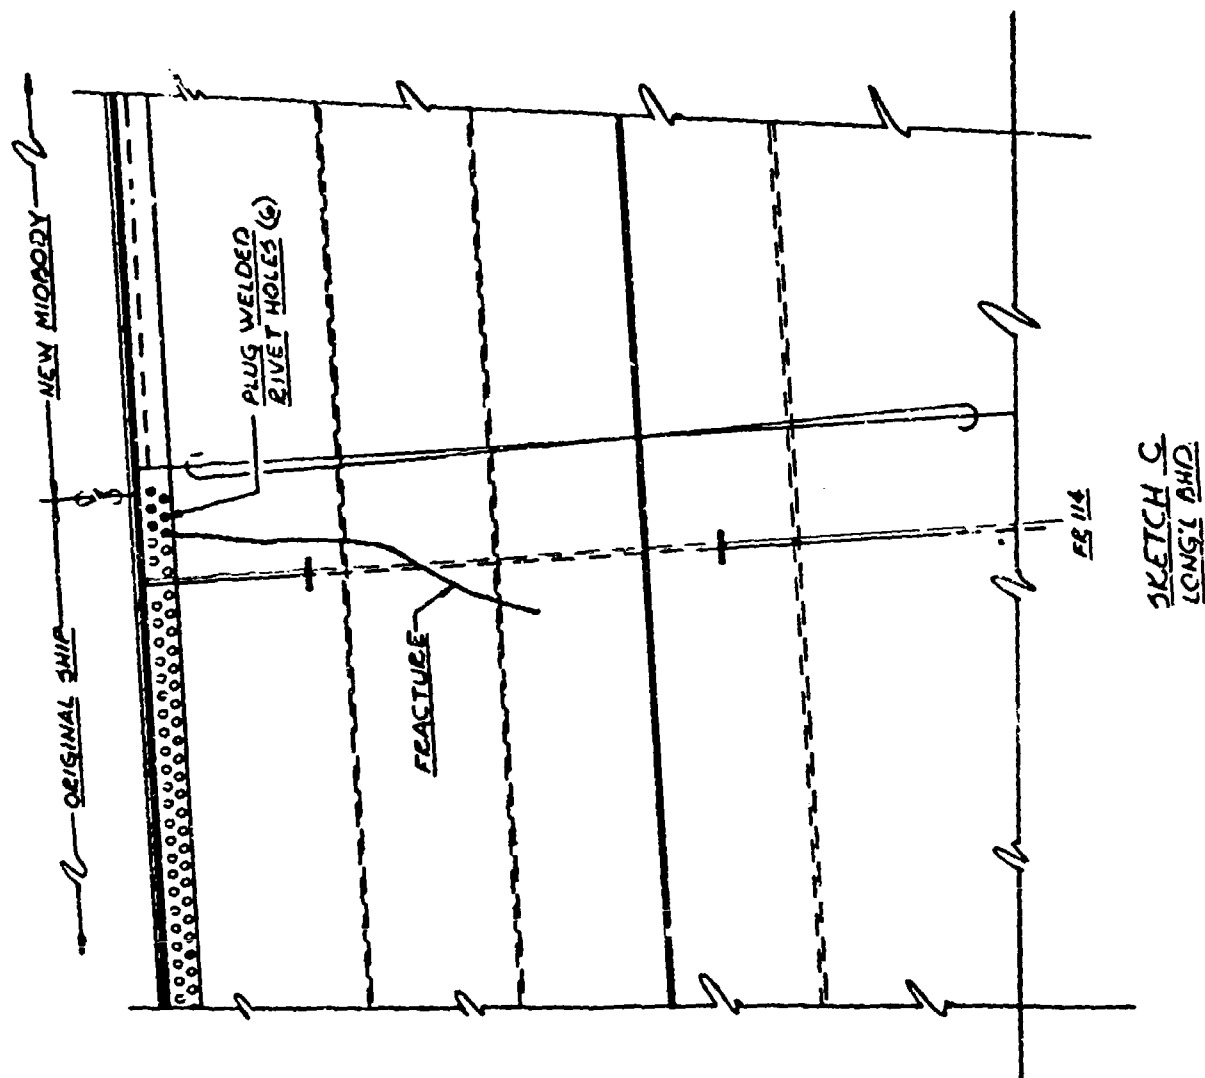
Figure 4-4. Fracture Path in the Longitudinal Bulkhead of the Great Lakes Bulk Carrier

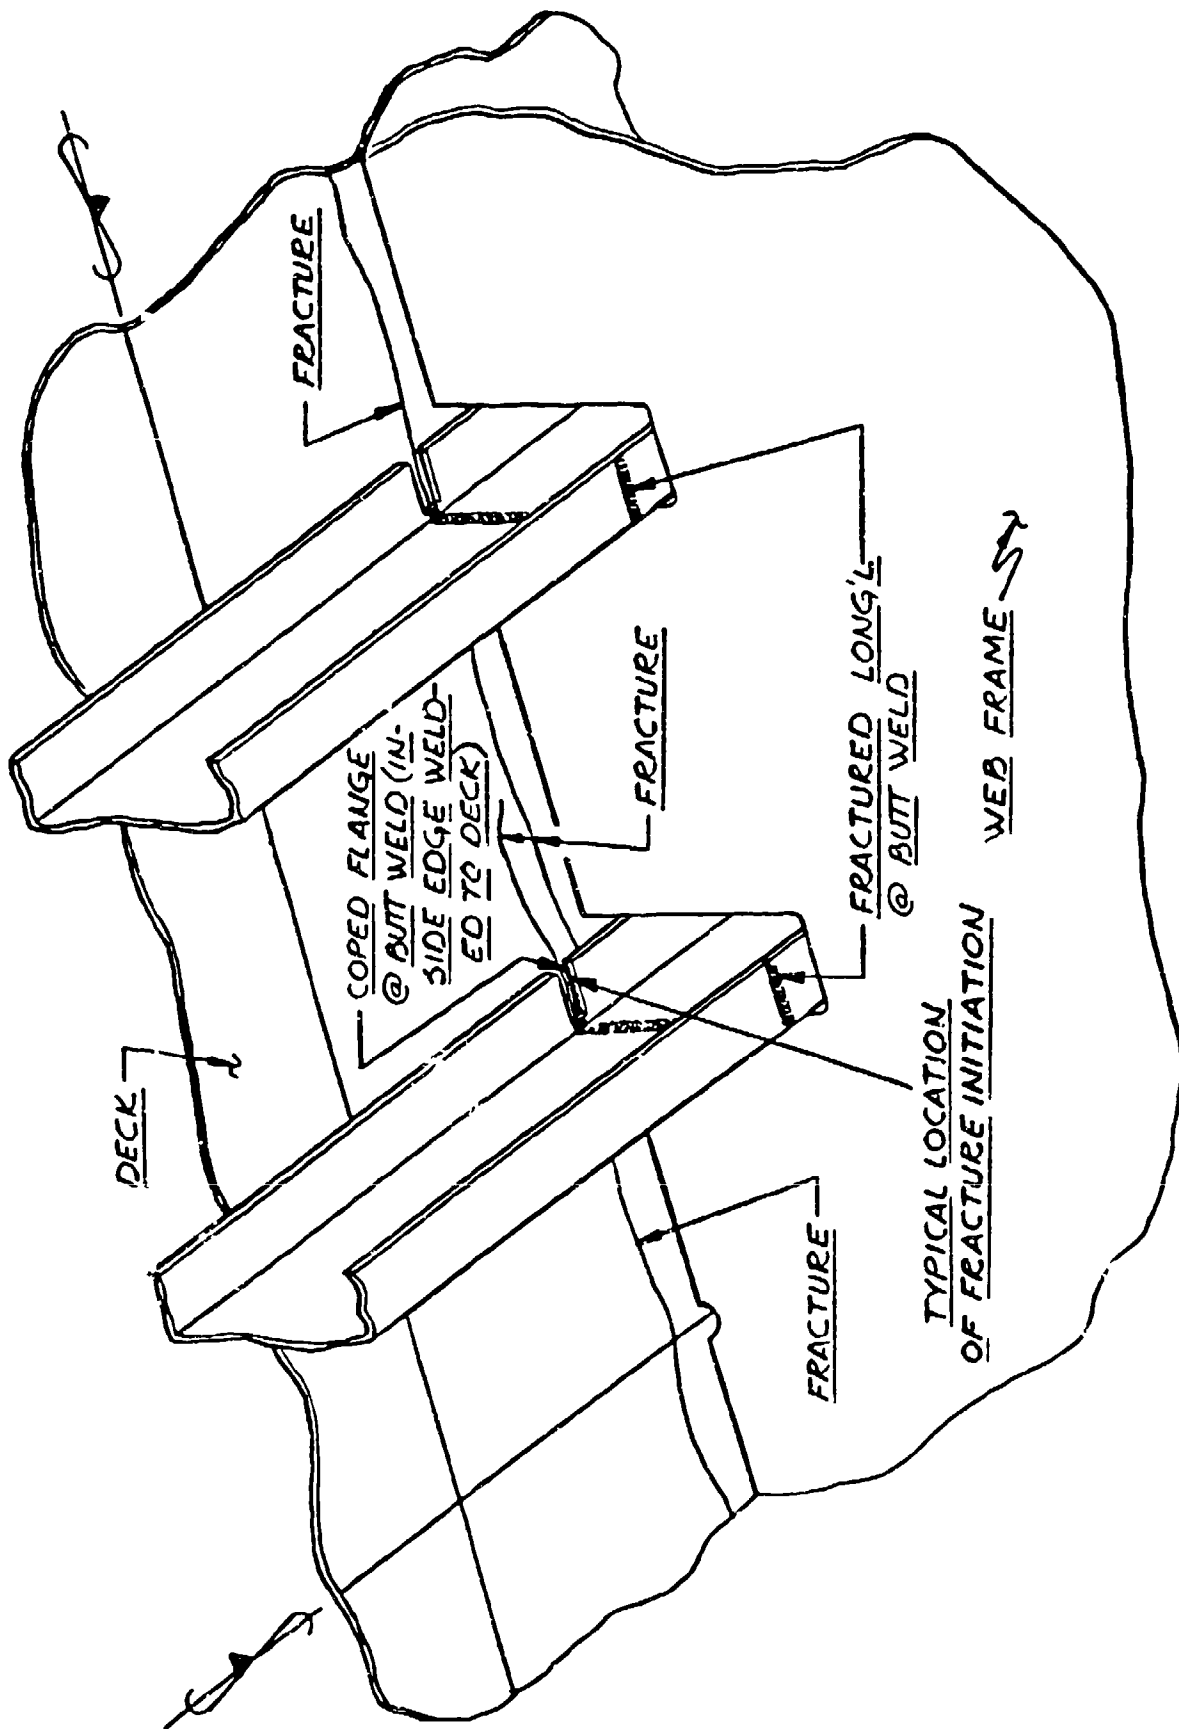
Figure 4-5. Construction Details Associated with the Initiation of the Fracture on the Great Lakes Bulk Carrier

The significant fractures all originated at longitudinals where the flange was cut for butt welding. The initiating defects at the origin were small. However, the ship operated for over 30 years with those poor fabrication details, suggesting relatively high forces in the ship structure from adverse weather at the time of fracture. This is also suggested by the multiple origin points. Because the fracture originated at poor fabrication details (notches), it is surprising that the ship survived in service for many years without fracturing.

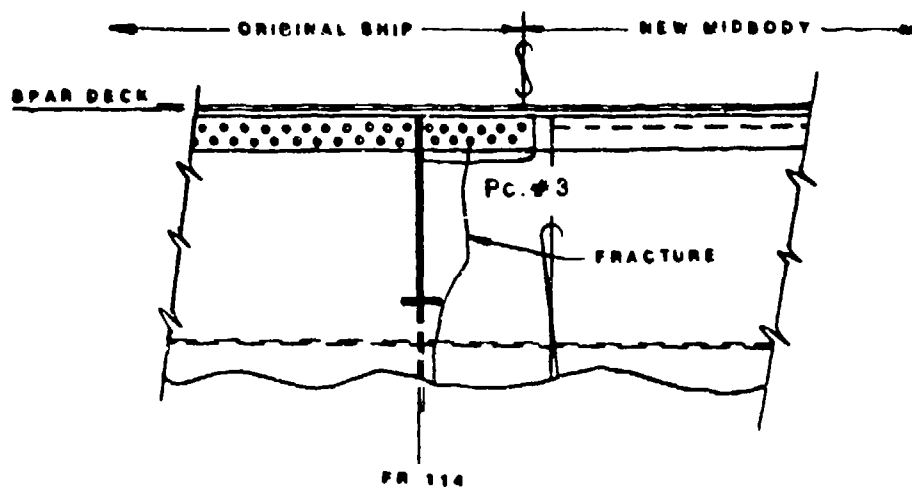
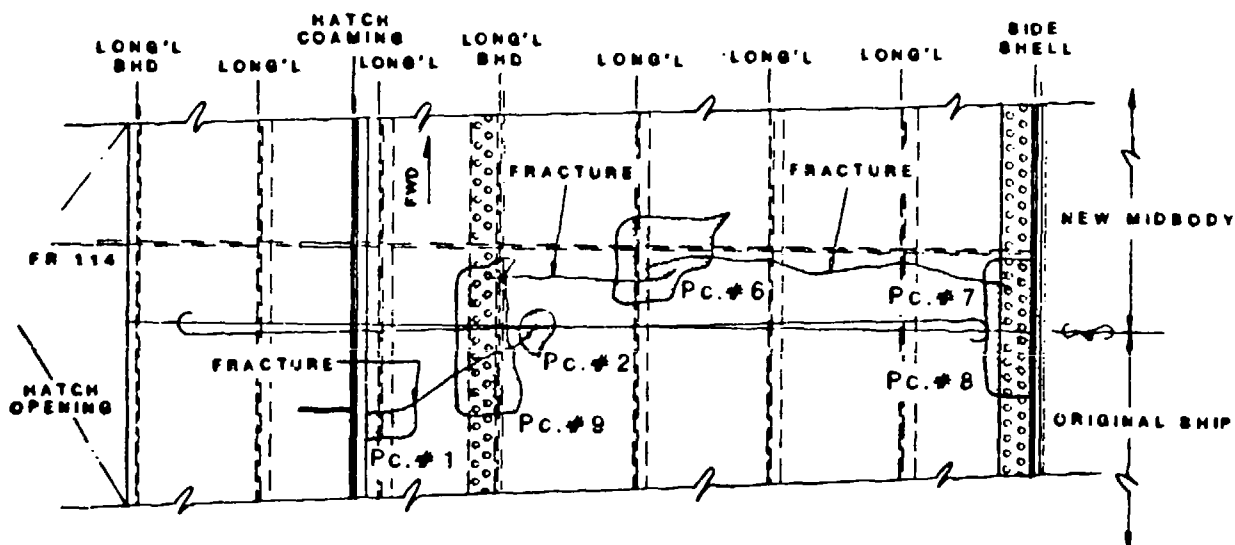
Figure 4-6. Location of Plating Samples from the Great Lakes Bulk Carrier.

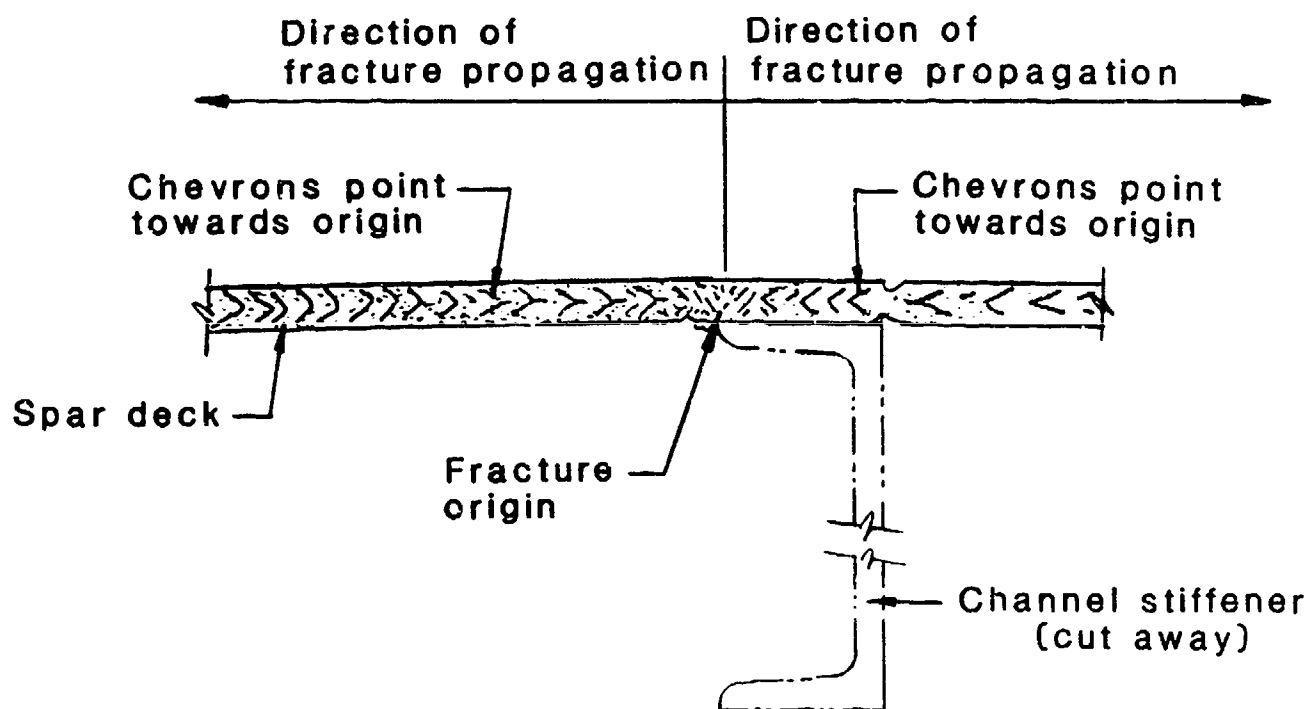
The origins of the various fractures were located by inspecting the edge of the fracture samples and establishing the orientation of chevron patterns. All the samples taken had clearly developed chevron marks. Examples of these markings on the surface of piece No. 1, which were typical, are seen in Figure 4-7. Sample No. 1 was cut from the spar deck plating located at the edge of the hatch coaming and extending outboard along part of the fracture surface as shown in Figure 4-6. Clear chevron markers point to the initiation site located in the transverse weld joining the coped out longitudinal flanges to the deck plate as shown in Figure 4-5. The fracture ran in two directions: under the hatch coaming and outboard across the deck through sample No. 9 and on into sample No. 2 where it terminated. As far as sample No. 9 is concerned, the fracture simply extended through this plate and did not directly result in propagation of fractures into the longitudinal bulkhead.

Figure 4-7. Location of the Fracture Origin in Sample Number 1.

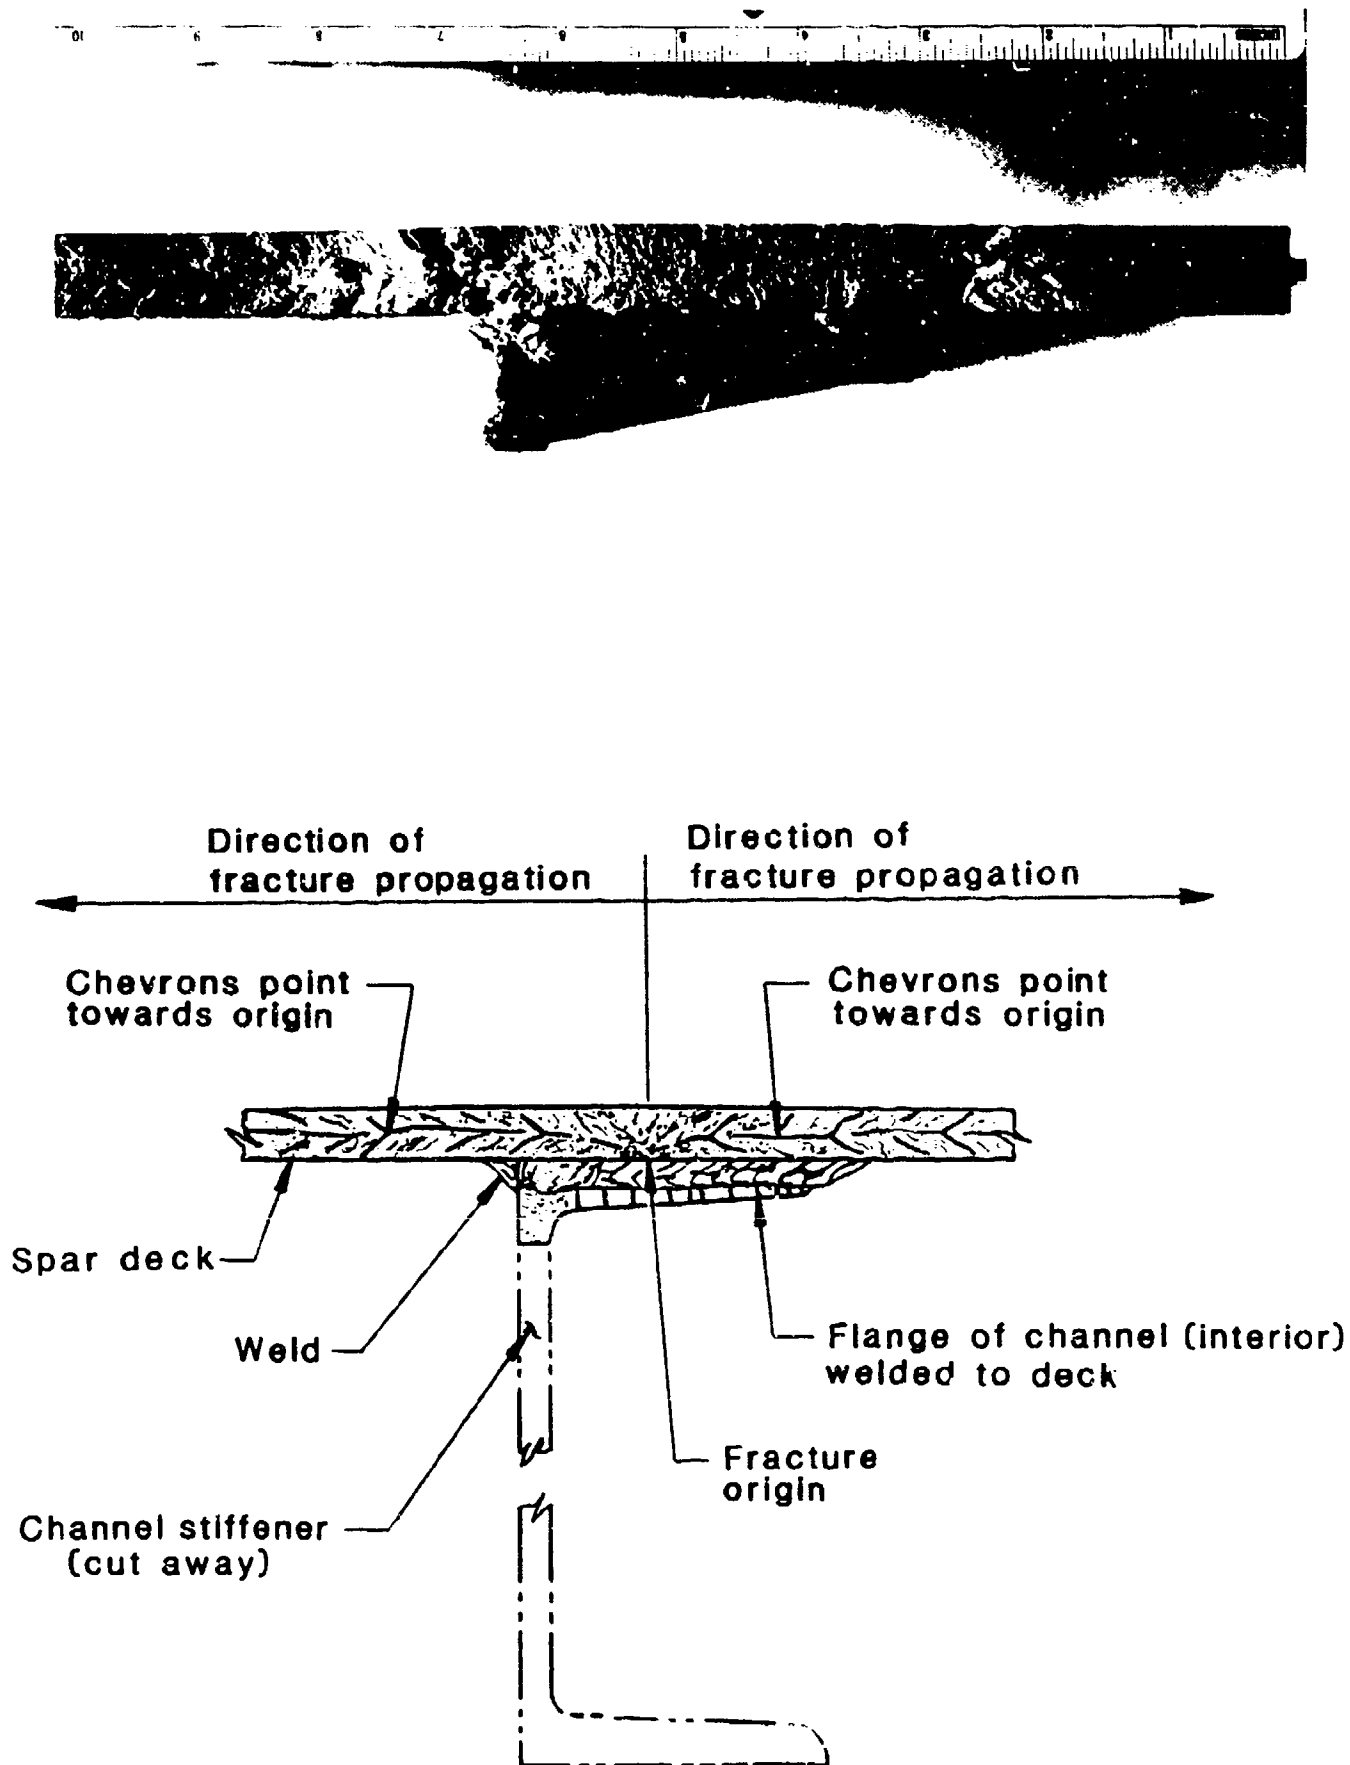
Sample No. 6 contains two separate fractures. Cutting the sample to reveal the fracture surfaces showed that the aft-most fracture extended inboard and outboard. From Figure 4-8 it can be seen that the chevrons point toward the

Figure 4-8. Location of the Fracture Origin in Sample No. 6.

weld of the flange cutout. The chevrons in the forward-most fracture in Sample 6 point outboard indicating that the fracture propagated inboard. The chevrons in the corresponding fracture in sample No. 7 point outboard indicating this fracture propagated inboard. Therefore, this fracture had to initiate somewhere between Samples Numbers 6 and 7, and shown in Figure 4-9 and probably at one of the two longitudinal flange cutouts.

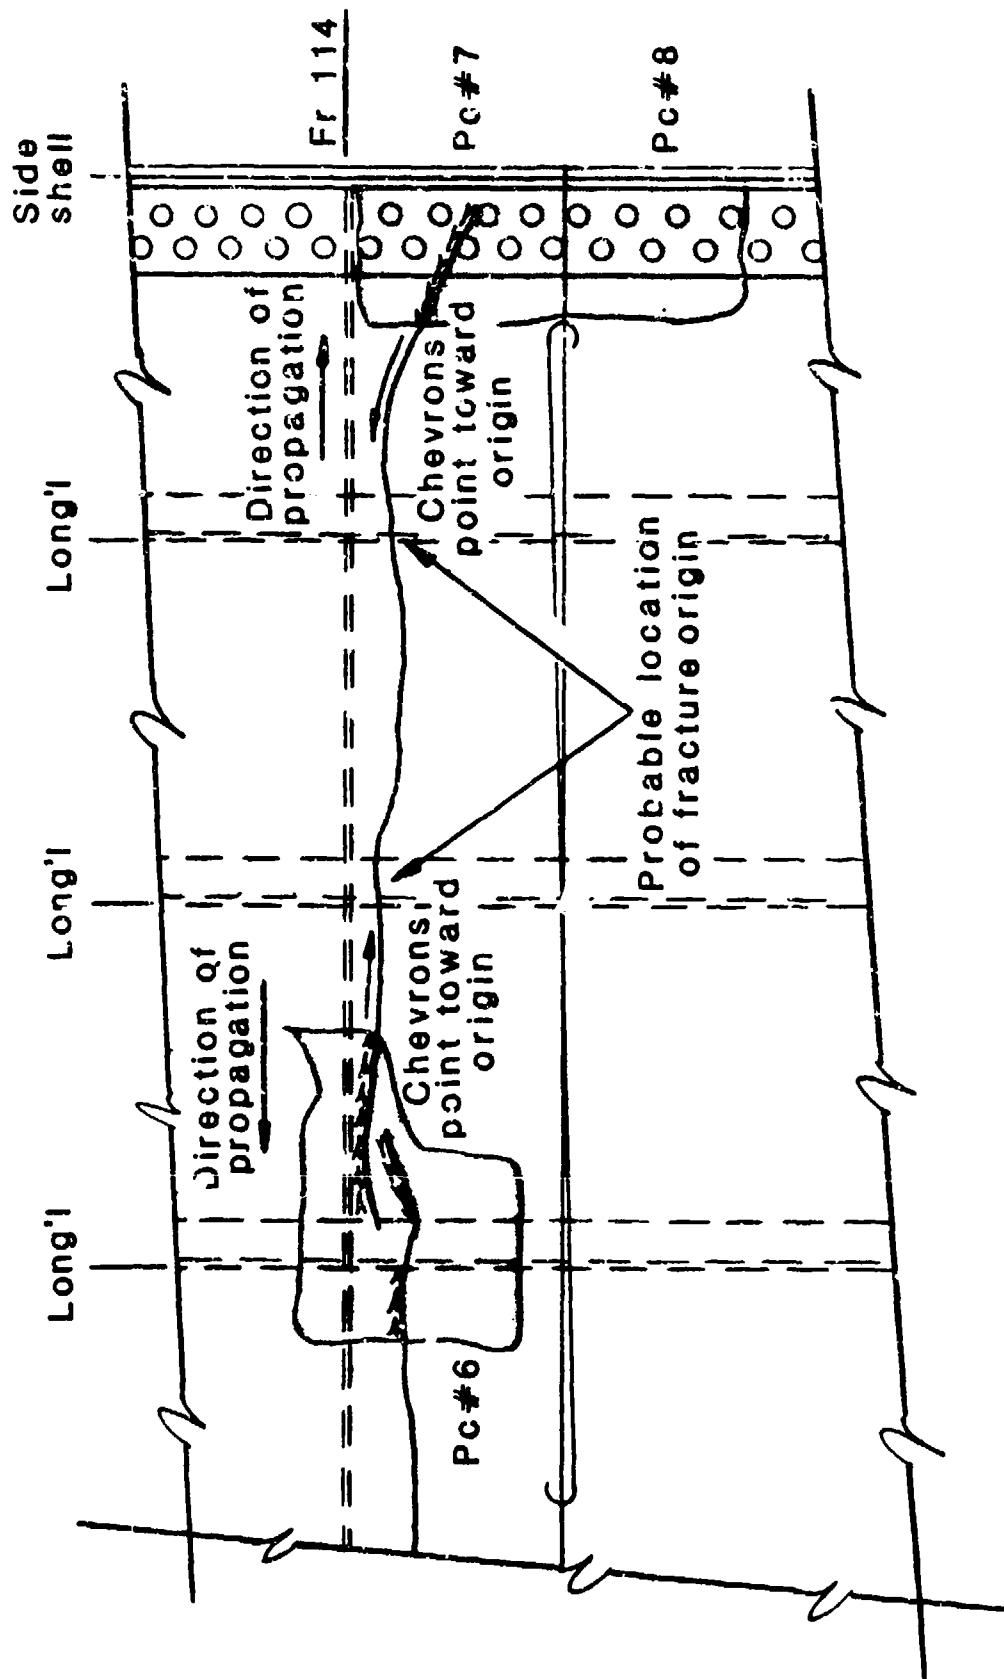
Figure 4-9. Fracture Propagation and Initiation between Sample No. 6 and No. 7.

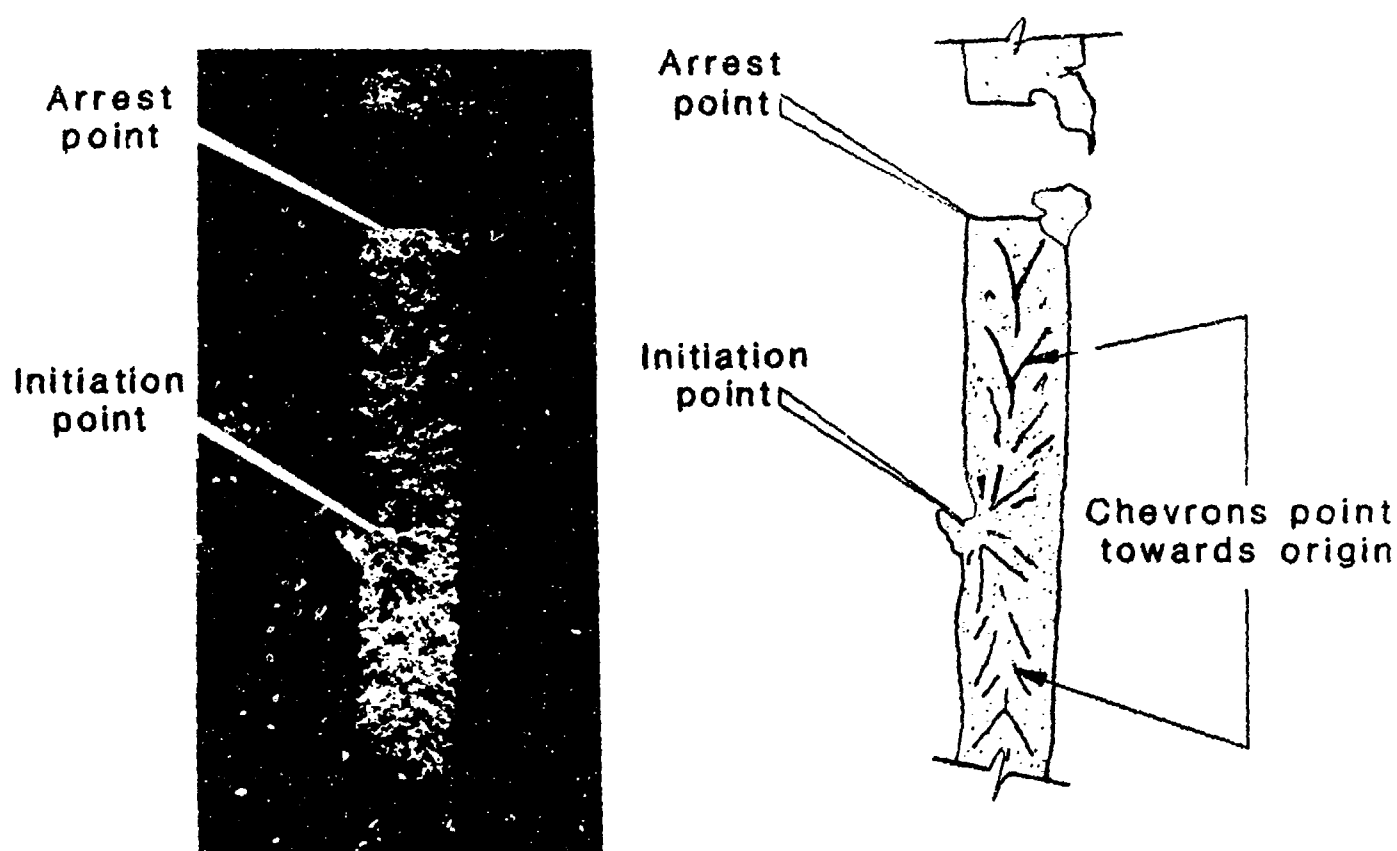
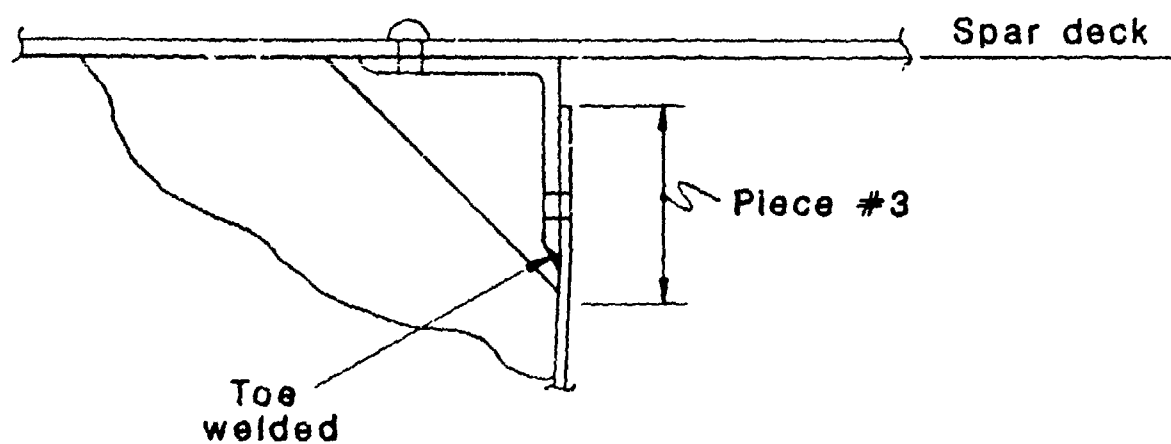
Figure 4-10. Piece No. 3 (Top of Longitudinal Bulkhead) Initiation Site Showing Crack Entering Piece No. 3 through Weld of Angle to Piece No. 3. Crack Goes to Rivet Hole on Right and Down the Bulkhead

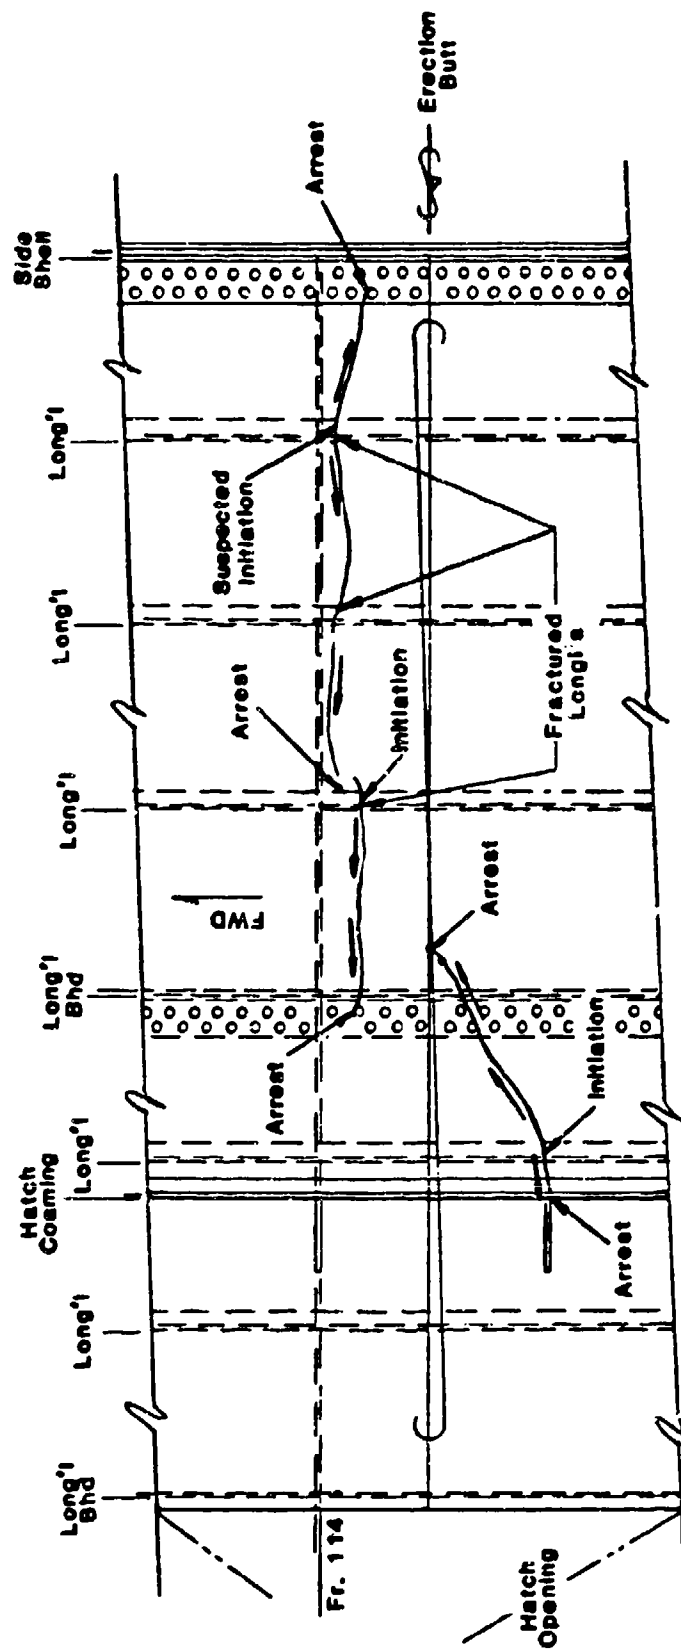
Figure 4-11. Plan of Spar Deck. Fracture Initiation and Arrest Points
